# Mendocino Coast District Hospital

SPC/NPC Overview Presentation I 05.05.2023

1.Review Definition of SPC & NPC2.Review SPC Upgrades On Campus3.Review NPC Upgrades On Campus4.Review New Hospital Construction5.Review Pricing

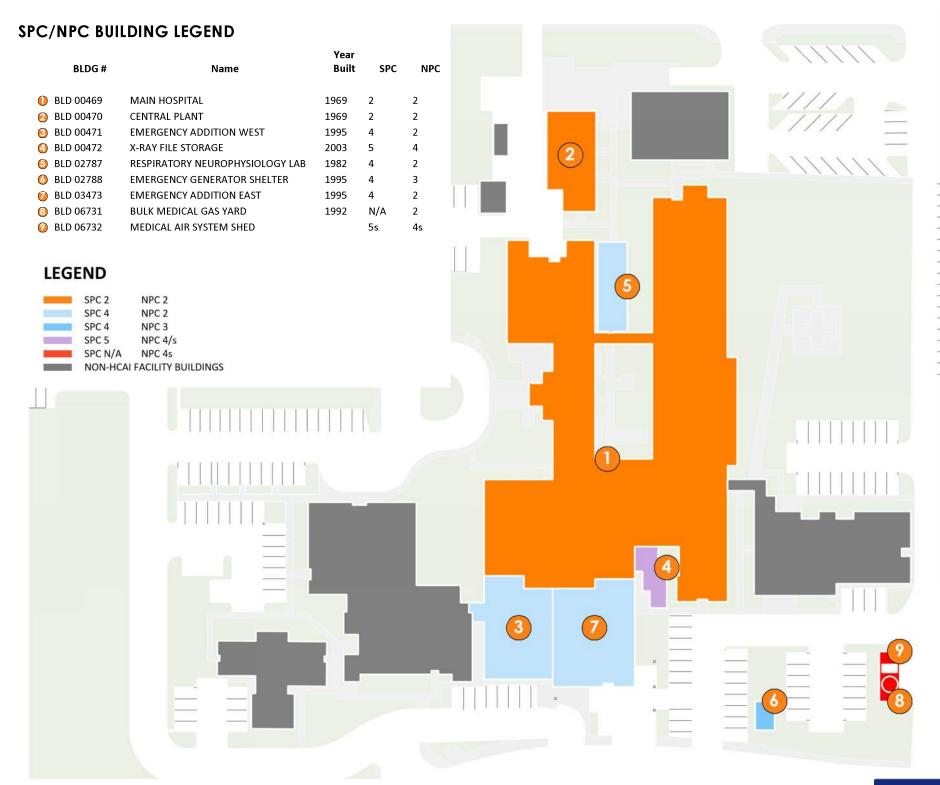
### Overview | SPC/NPC Site Plan

#### **OVERALL (HCAI) CAMPUS:**

#### **2030 SPC NON-COMPLIANT:**

#### **2030 NPC NON-COMPLIANT:**

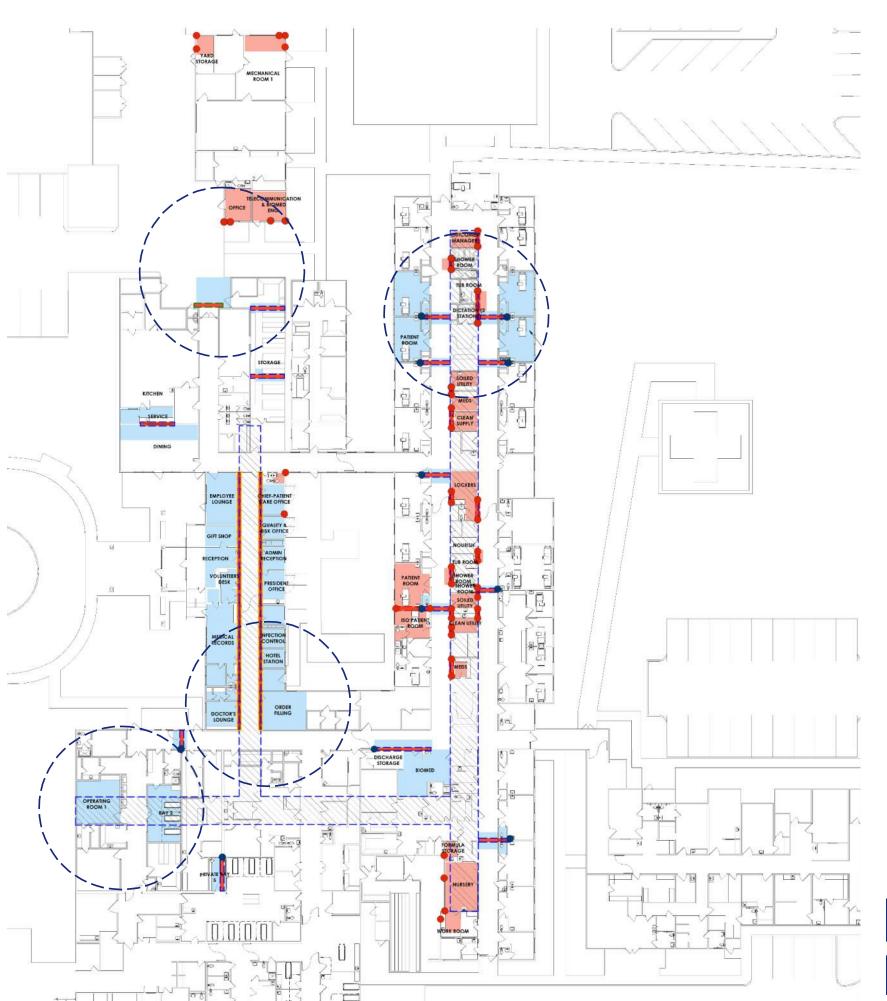
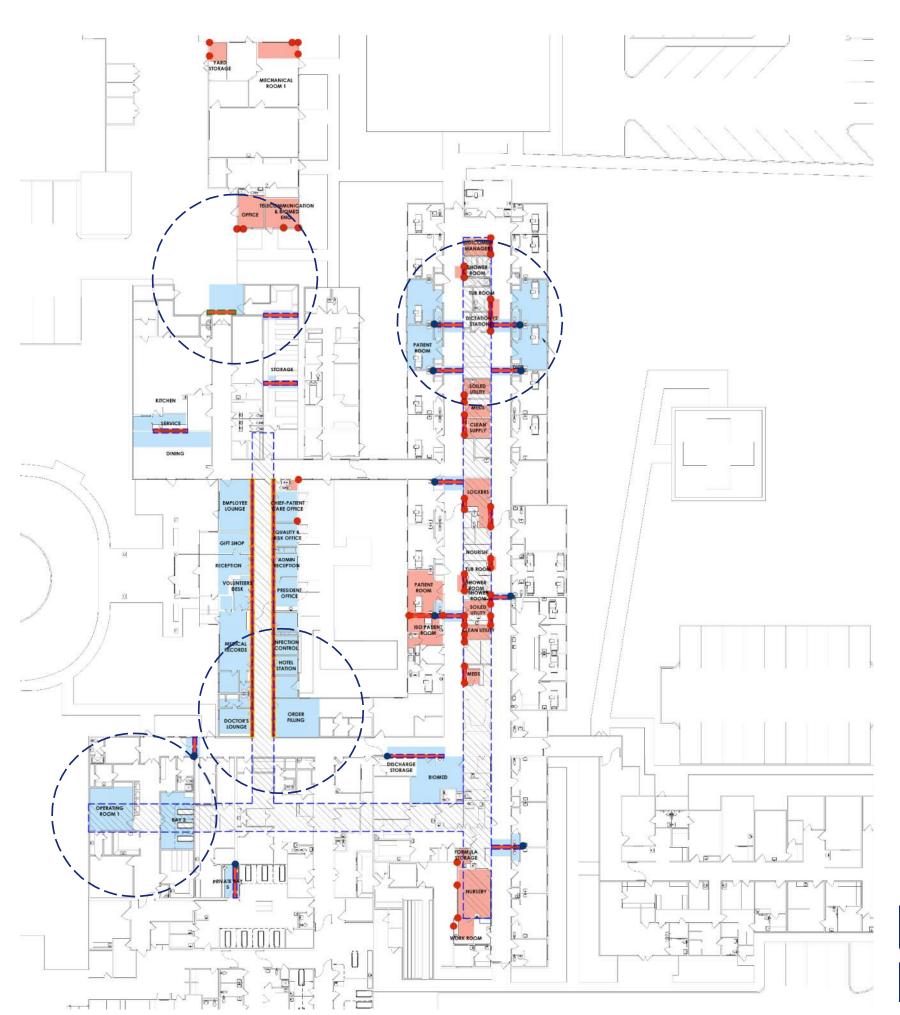
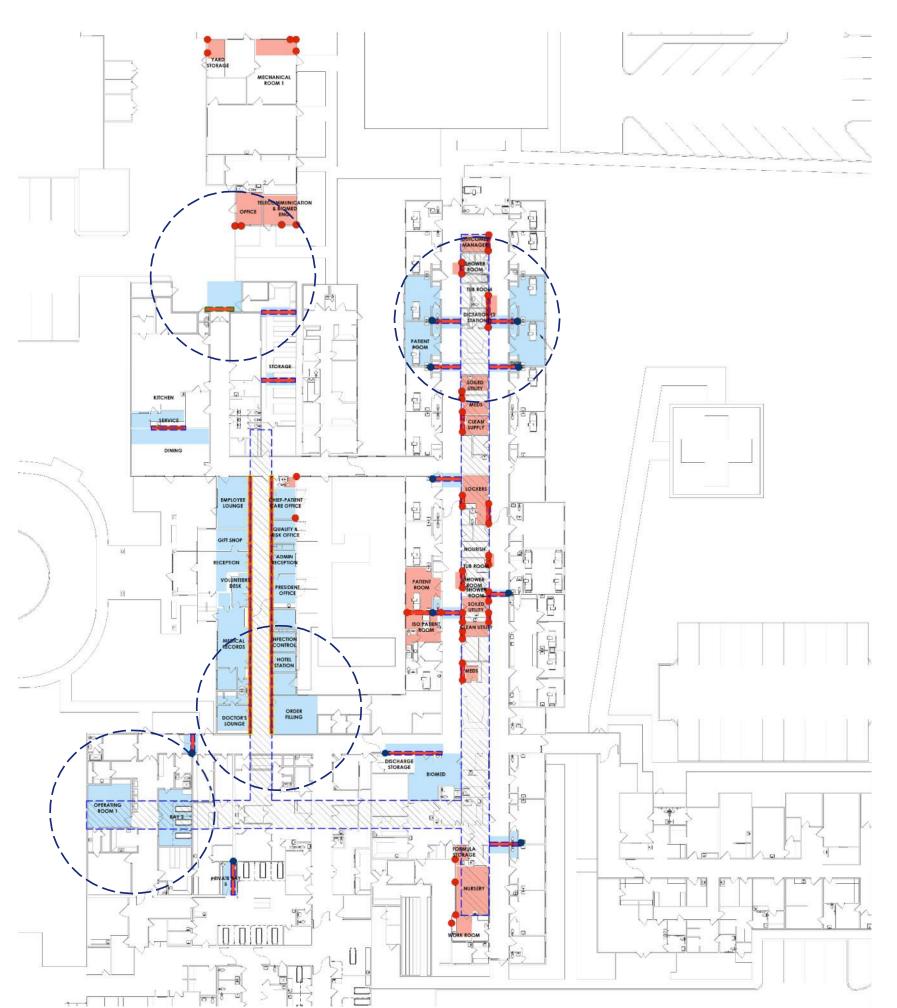
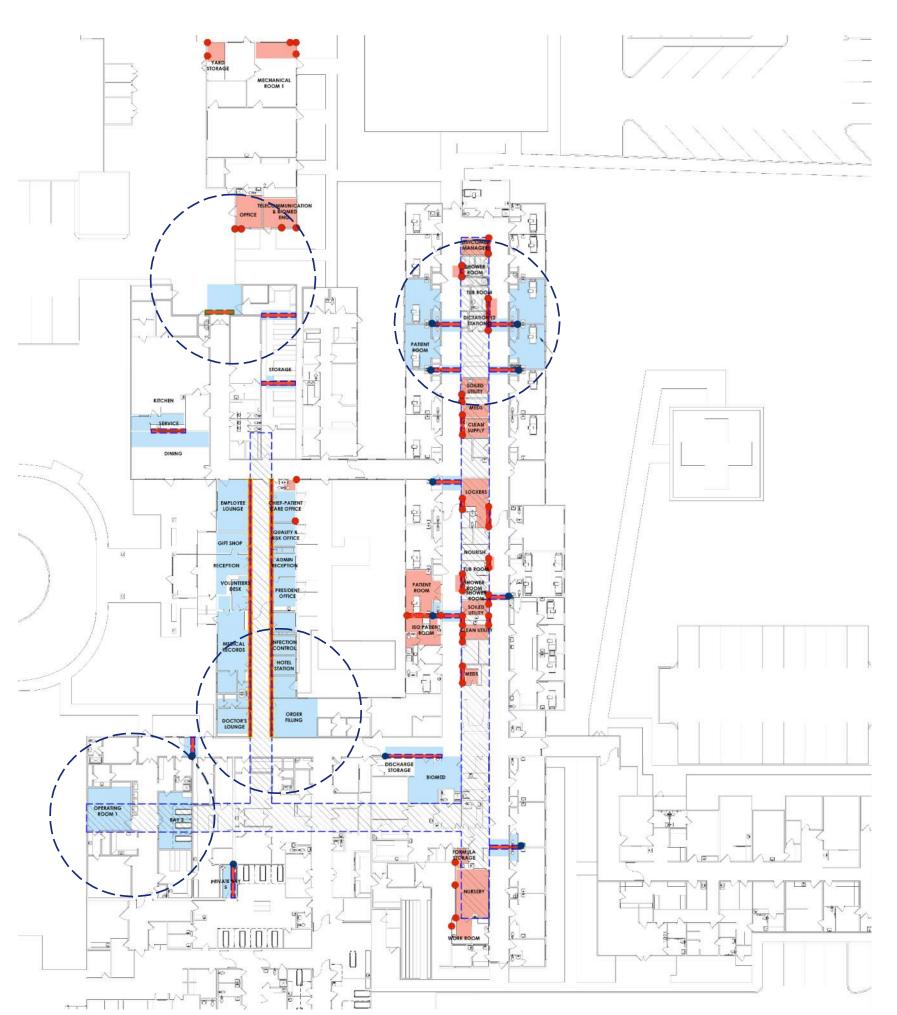
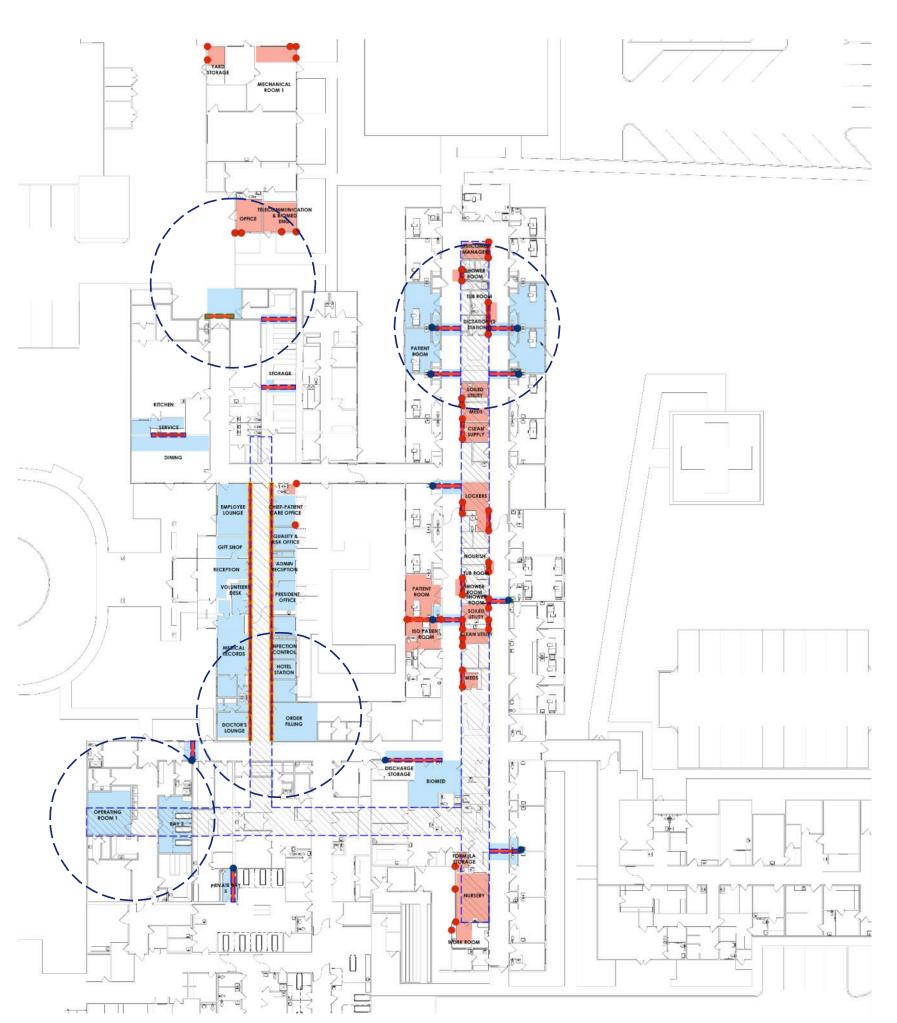
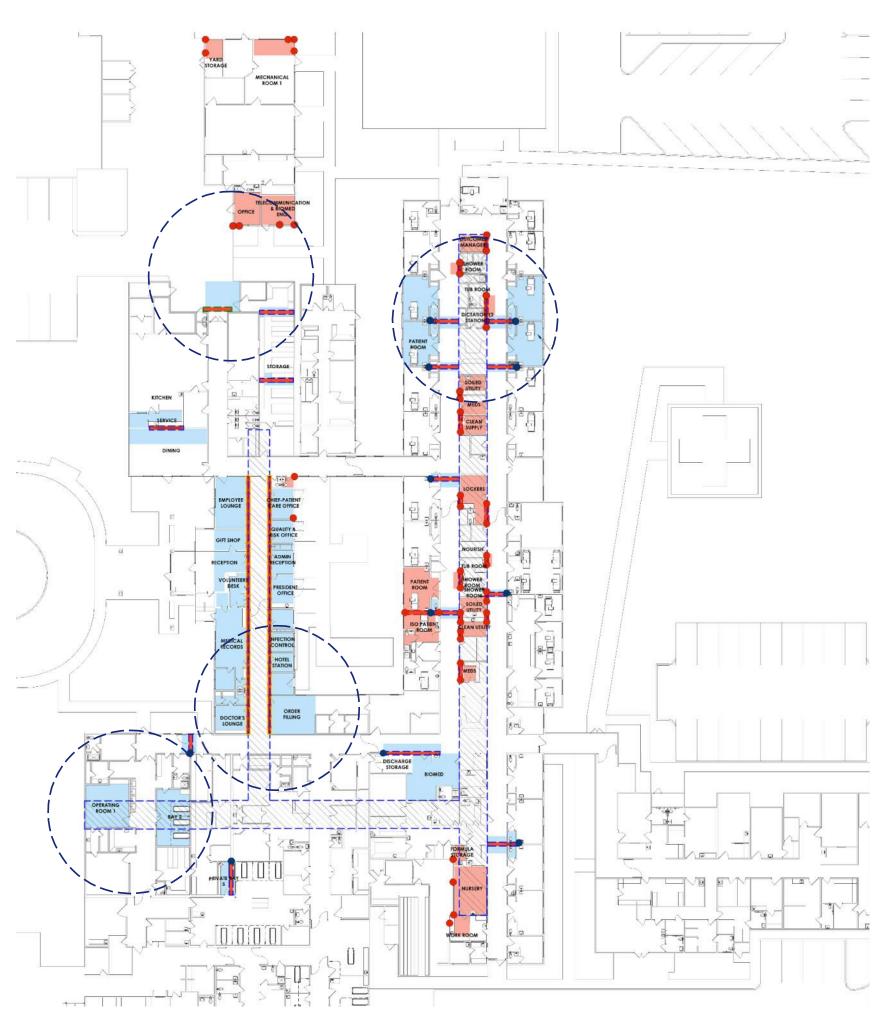
NEW CONCRETE EXPANSION ANCHORS

ROOF COLLECTOR STRENGTHENING

NEW STRAP AND 4' SCAB ALONG SIDE OF ROOF JOIST

NEW PLYWOOD SHEATHING @ CEILING

NEW CABLE SPACING IN ATTIC ABOVE

**NEW SEISMIC GAP BETWEEN BUILDING**

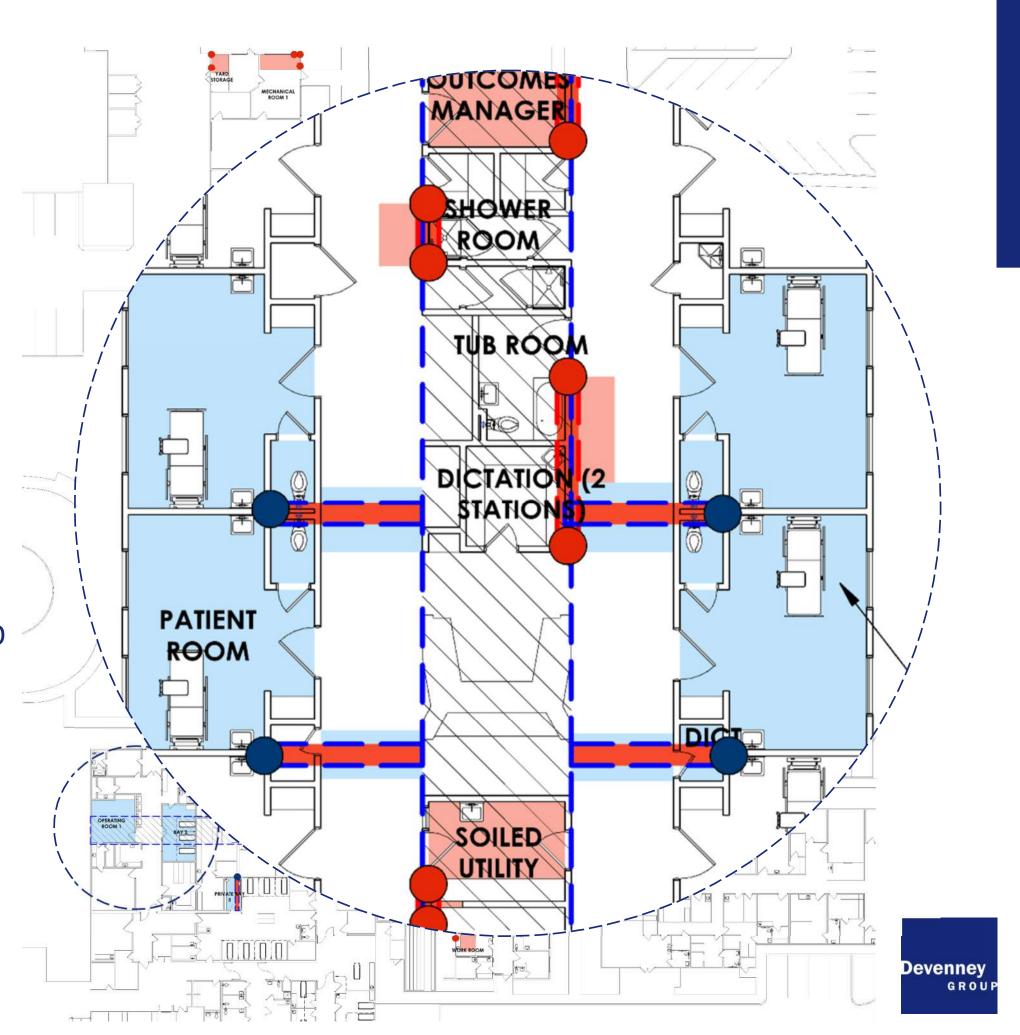
# NEW HOLDOWN NEW CONCRETE EXPANSION ANCHORS

- CONSTRUCTION WILL HAPPEN WITHIN MOST SUPPORT ROOMS LIMITING IMPACT TO OPERATIONS
- AT TUB ROOMS OR SHOWER ROOM THE CONSTRUCTION WILL HAPPEN IN CORRIDOR TO NOT REQUIRE ACCESSIBILITY UPGRADES TO ROOM
- AT CORRIDOR CONSTRUCTION TEMPORARY INFECTION CONTROL BARRIERS WILL BE NEEDED AND MAY IMPACT OPERATIONS THROUGH CORRIDOR

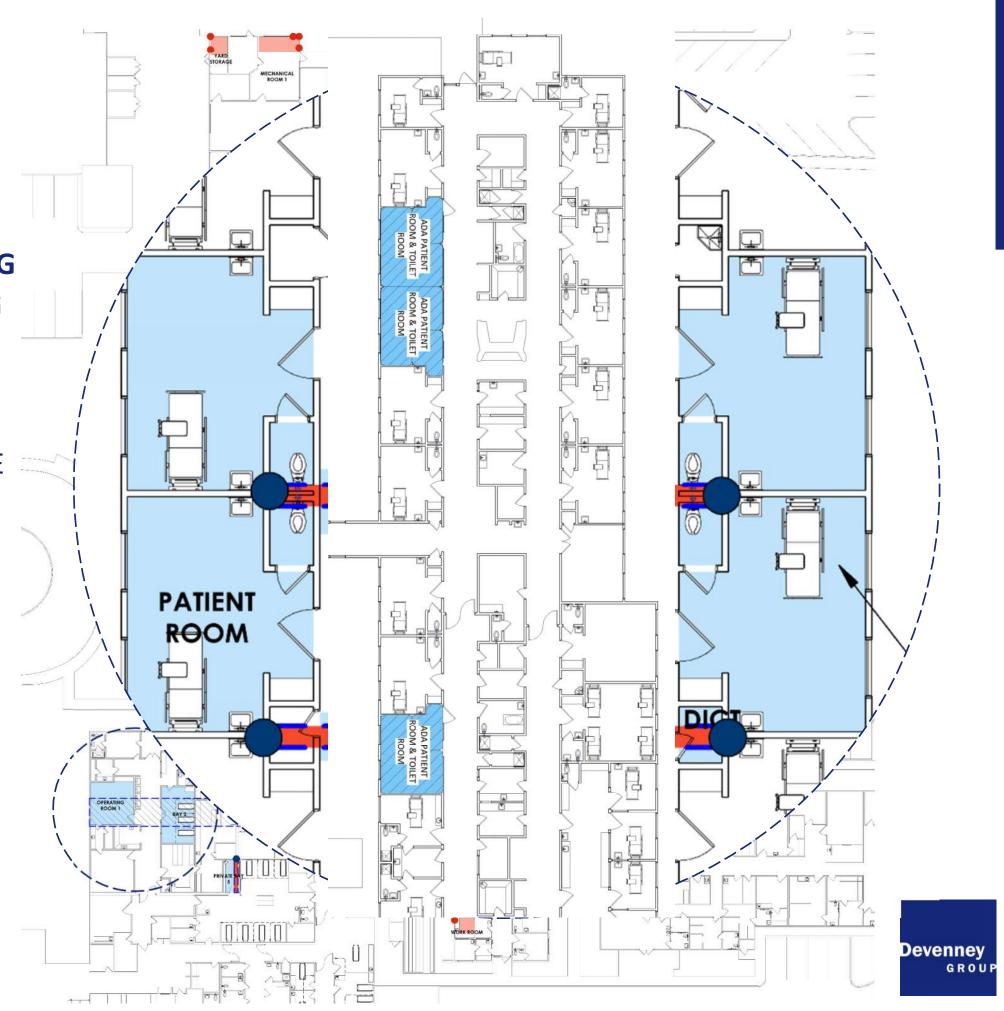
# ROOF COLLECTOR STREGTHENING NEW STRAP AND 4' SCAB ALONG SIDE OF ROOF JOIST

- WORK WITHIN PATIENT ROOM
  WILL REQUIRE UPGRADE TO
  10% OF PATIENT ROOMS TO BE
  ACCESSIBLE, APPROXIMATELY
  (3) ROOMS
- REQUIRES APPROXIMATELY
   1,000 SF OF CONSTRUCTION

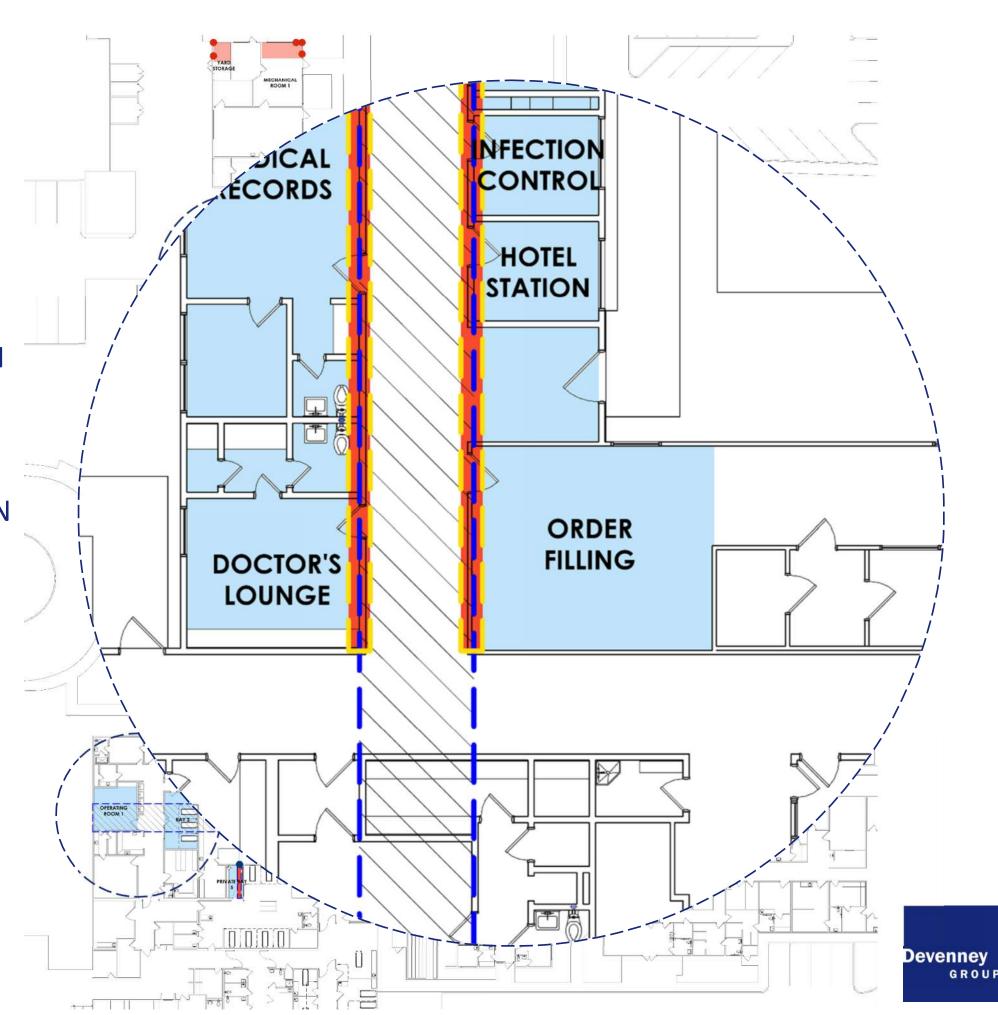
### NEW PLYWOOD SHEATHING @ CEILING

- CONSTRUCTION WILL HAPPEN ABOVE CEILING
- MOST WORK IS IN ADMIN AREA AND FRONT LOBBY
- LARGEST IMPACT TO OCCUR IN PHARMACY

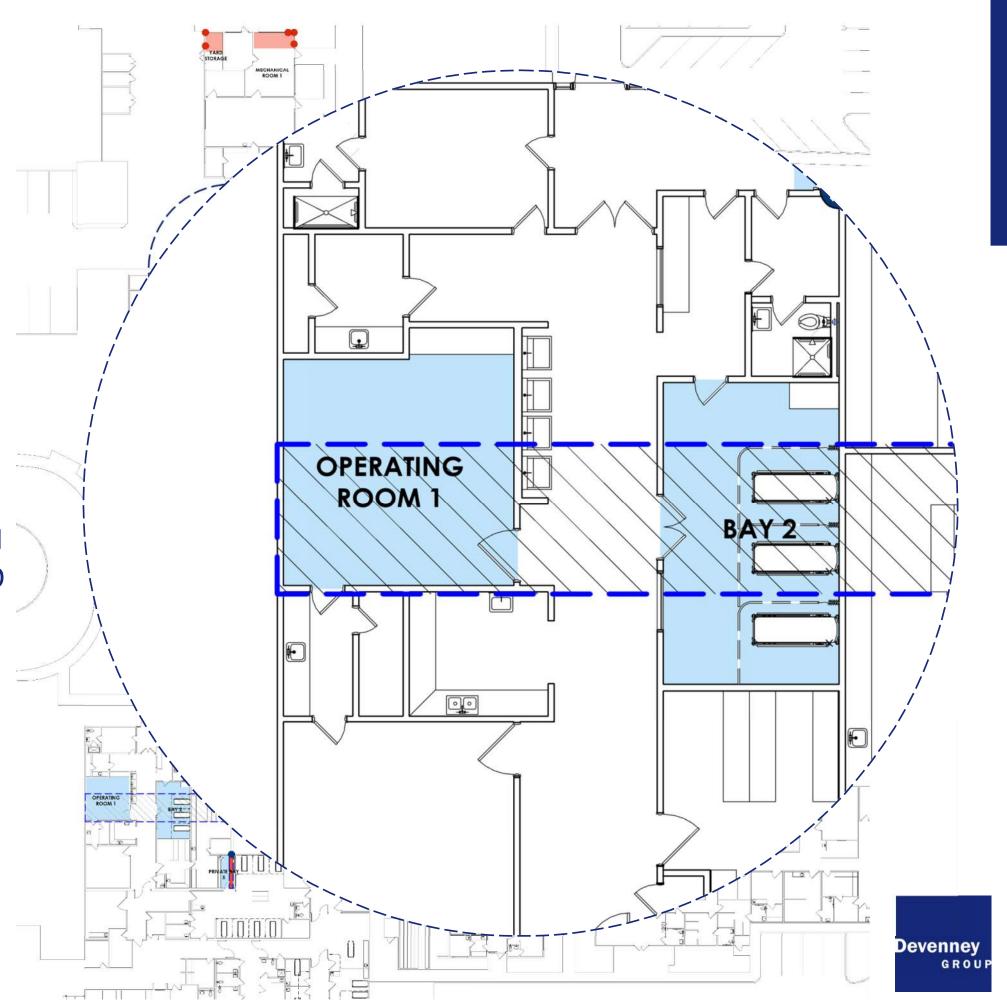
### NEW CABLE SPACING IN ATTIC ABOVE

- CONSTRUCTION WILL HAPPEN IN ATTIC
- MOST WORK IS ABOVE SUPPORT AREAS NOT IMPACTING OPERATIONS
- LARGEST IMPACT TO OCCUR IN SURGERY – CONSTRUCTION TO BE COORDINATED AROUND SURGERY TIME TO NOT DISRUPT OPERATIONS

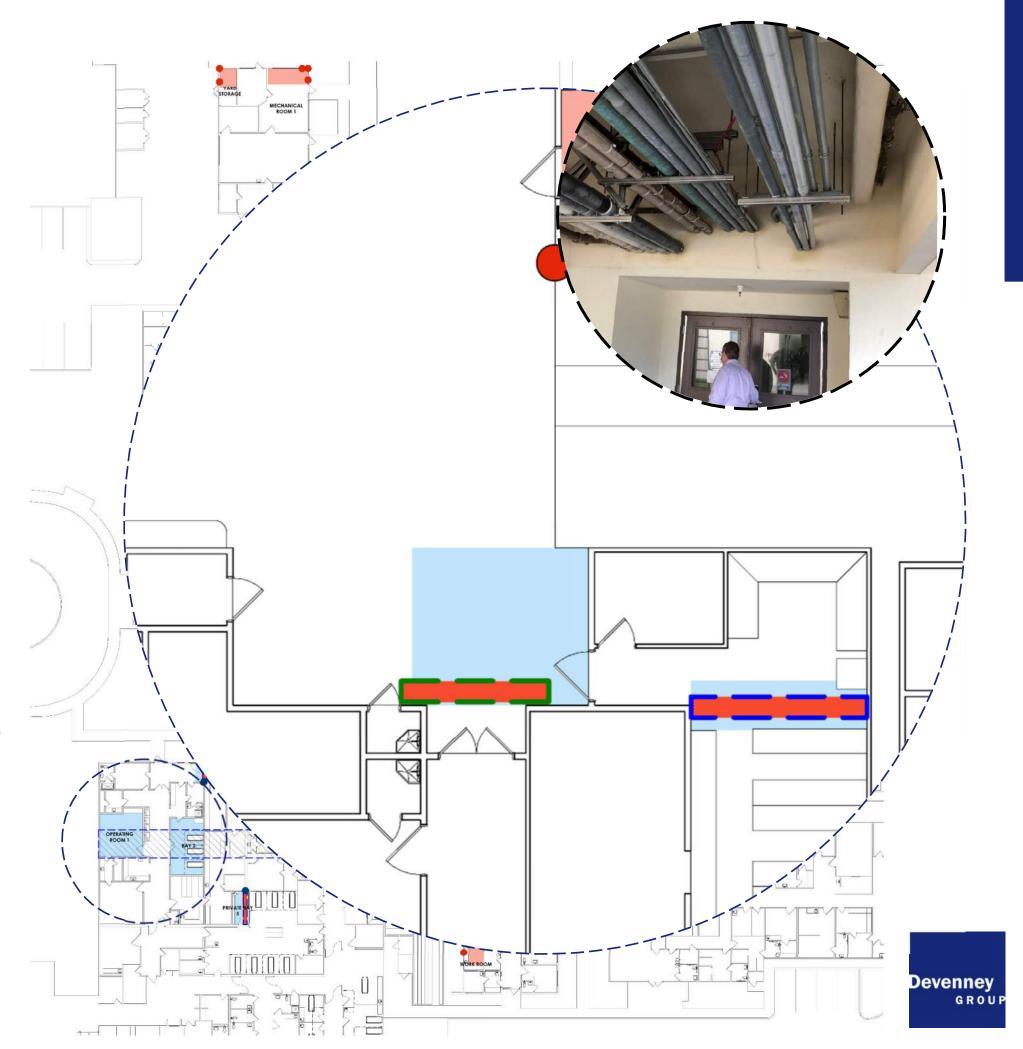
#### **NEW SEISMIC GAP BETWEEN BUILDING**

- CONSTRUCTION REQUIRES ADDING SEISMIC GAP AND **SEISMIC CONNECTIONS OF UTILITIES BETWEEN CANOPY** FROM CUP AND MAIN **HOSPITAL BUILDING**
- WILL IMPACT ALL UTILITIES **GOING INTO THE FACILITY** FROM CUP
- POTENTIAL TO LOSE UTILITIES **DURING CERTAIN TIMES DURING CONSTRUCTION**

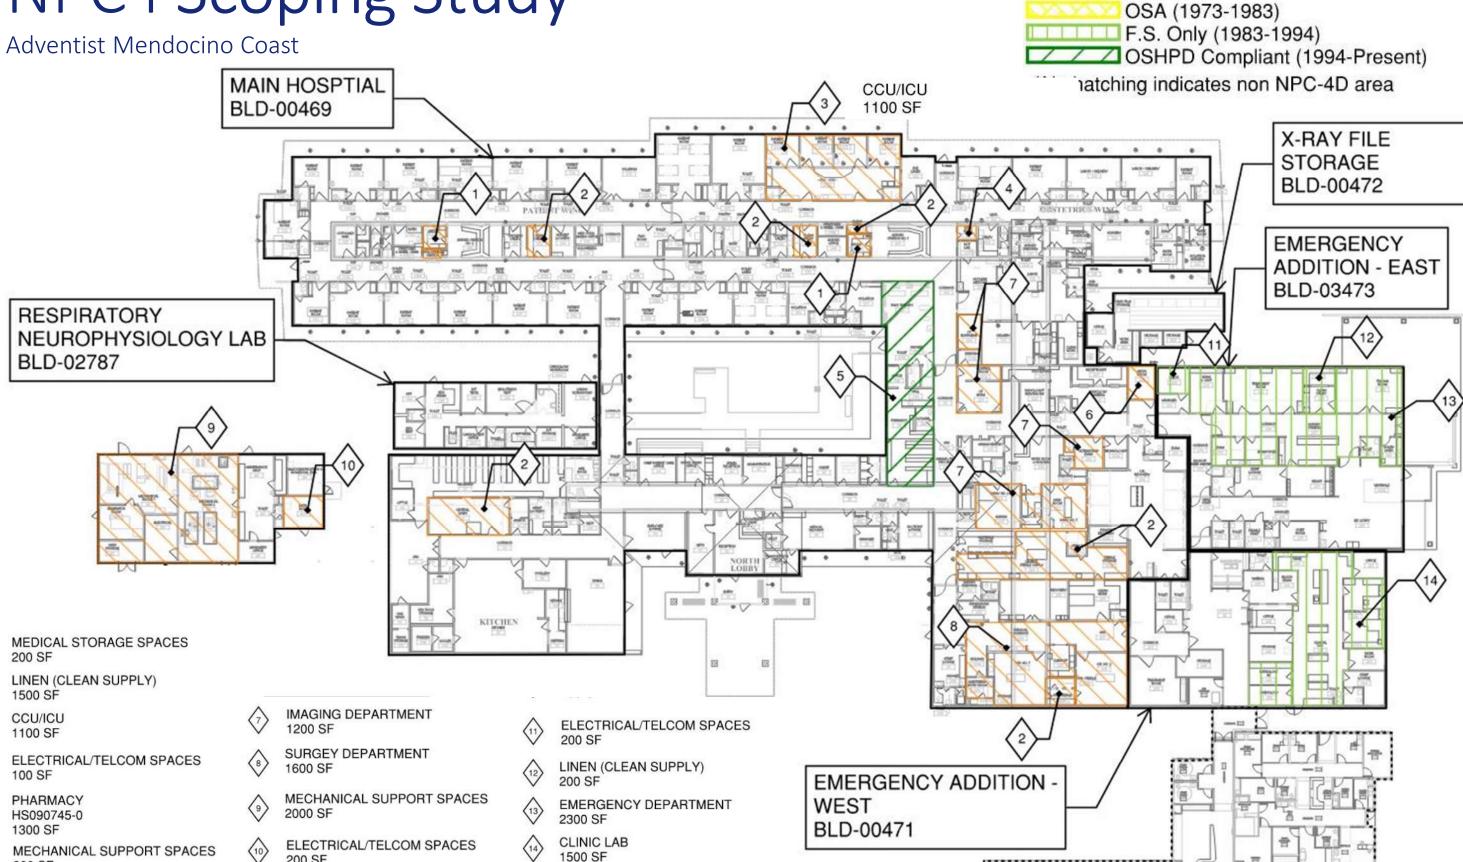
## NPC | Scoping Study

LEGEND:

PRE-1973

Categorize each building based on year of design code and type of permit, which is primary indicator of extent of NPC work required within the building. Main Categories are:

- Outline Boundaries of critical care departments within each building on floor plans provided
- The boundaries consider the extent of departments that fall within the critical care definitions of the CBC
